UNDERWATER BRIDGE INSPECTION REPORT

STRUCTURE NO. 73534

SAUK RIVER

DISTRICT 3 – STEARNS COUNTY

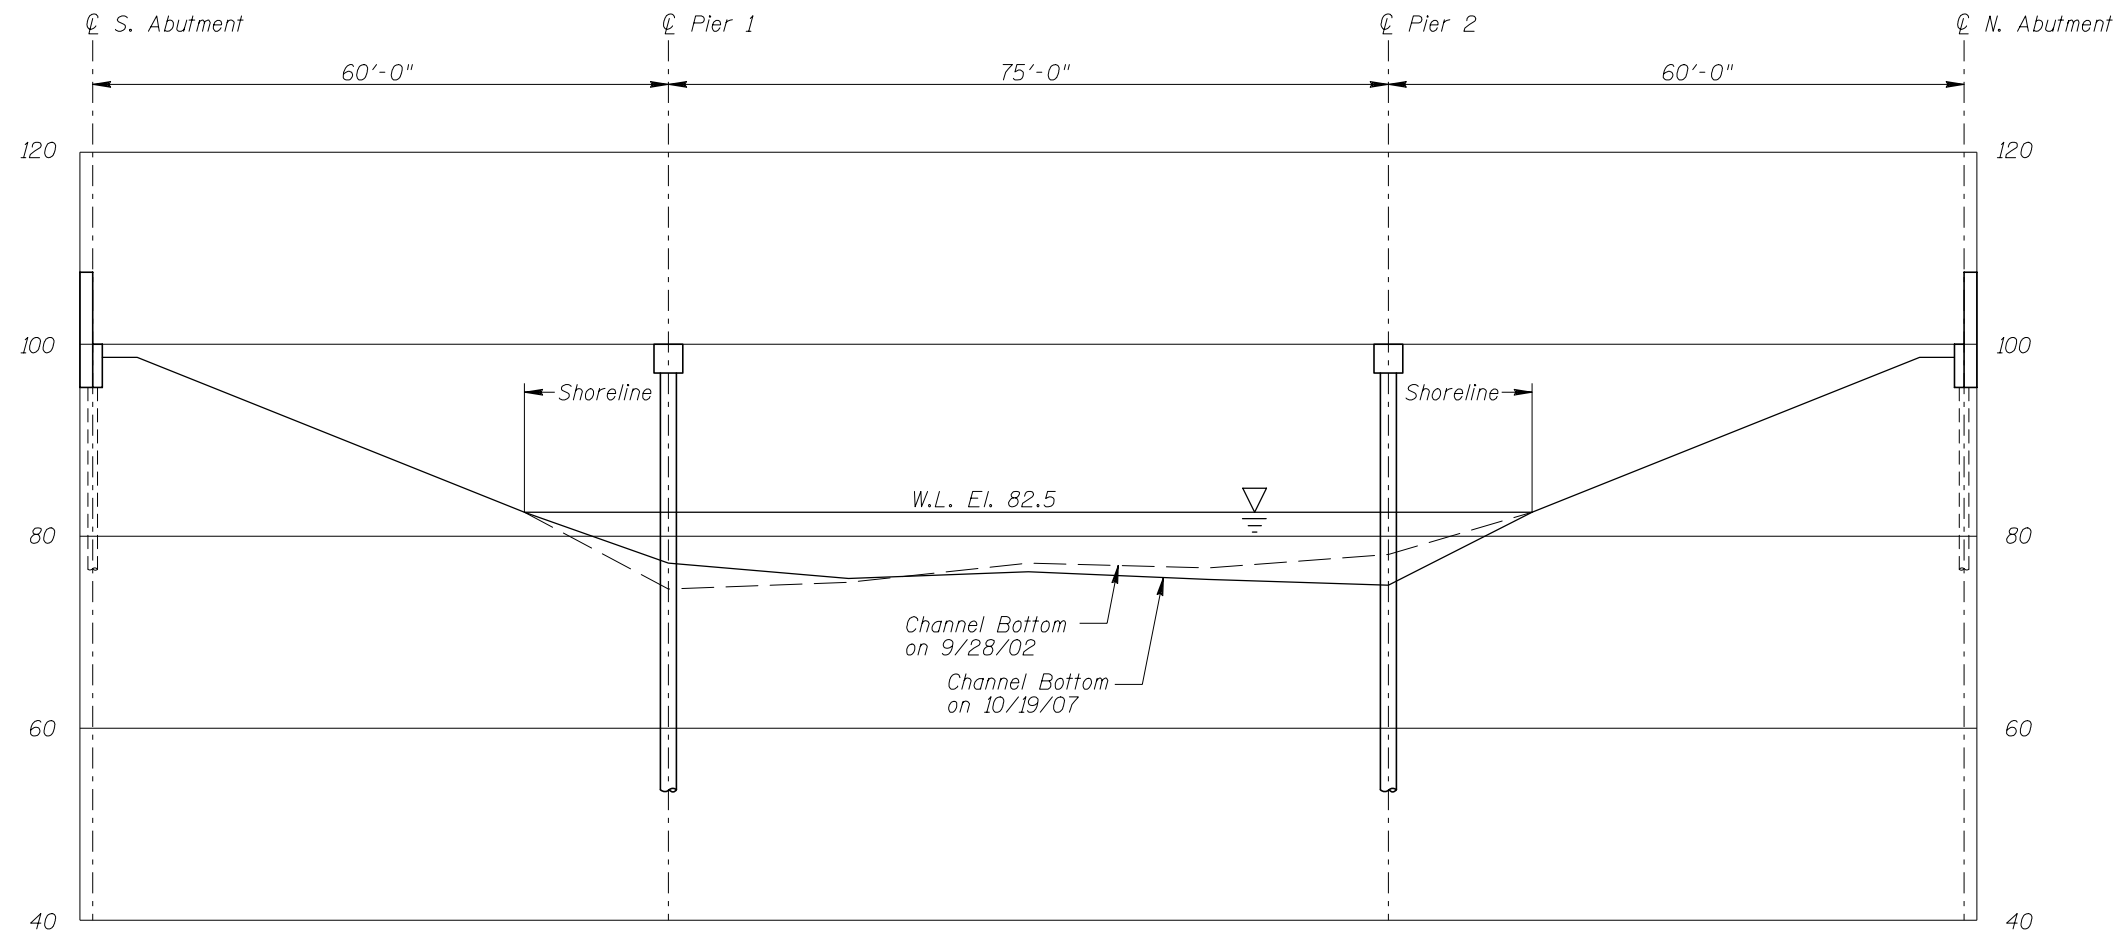
UPSTREAM FASCIA PROFILE

- The channel bottom consisted of sand and silt with 1 to 2 foot diameter riprap and 3 inches of probe rod penetration.
- The channel bottom consisted of sand and gravel with up to 4 inches of probe rod penetration.
- The steel piles exhibited coating failure and fairly uniform surface corrosion from 1 foot above the waterline to the channel bottom with random rust nodules up to 1/2 inch in diameter with pitting 1/16 inch deep, over 10 percent of the surface area.
- Light accumulation of timber debris consisting of 3 inches in diameter and smaller branches was observed scattered along entire perimeter of Pier 2.
